# 2017 Dry Run Creek Geomorphological Watershed Assessment

2016/2017 Academic Year  
By: University of Northern Iowa  
Dept. of Earth and Environmental Science  
Geomorphology Class Project

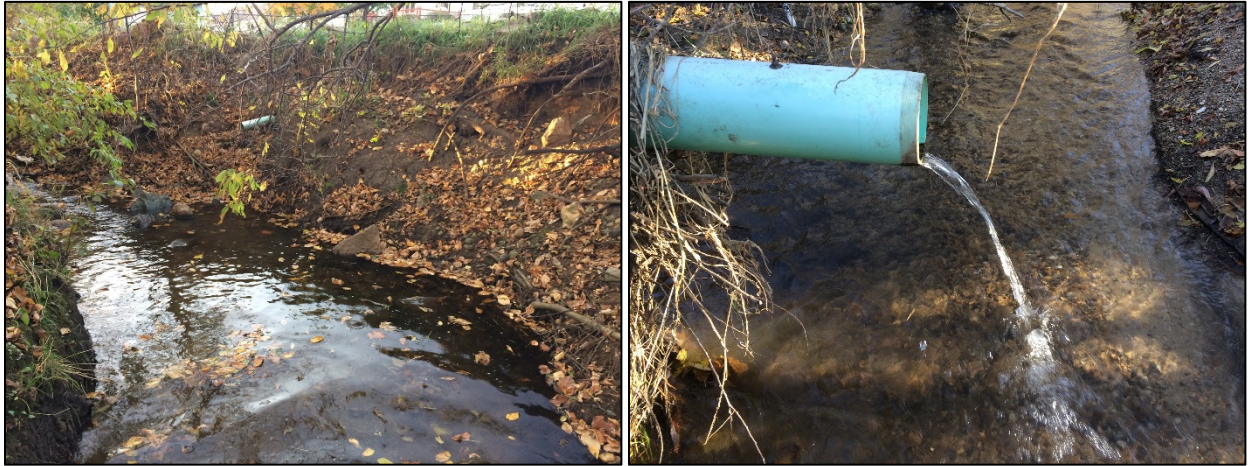
Agricultural and urban land coming directly up to the stream banks leaves little to no buffer zone capable of decreasing the velocity of water and/or contaminants moving from the land towards the stream. In order to improve water quality, in-stream habitat, and/or bank stability, the Dry Run Creek Improvement Project should continue encouraging remediation practices in these zones of high instability. Point source runoff from agricultural and urban tiling was identified throughout the watershed (Figure 40).

Figure 40. The images above provide examples of what this point source runoff looks like in the field. The image on the left show point source runoff in an urban area, while the image on the right shows a farm tile entering the stream.

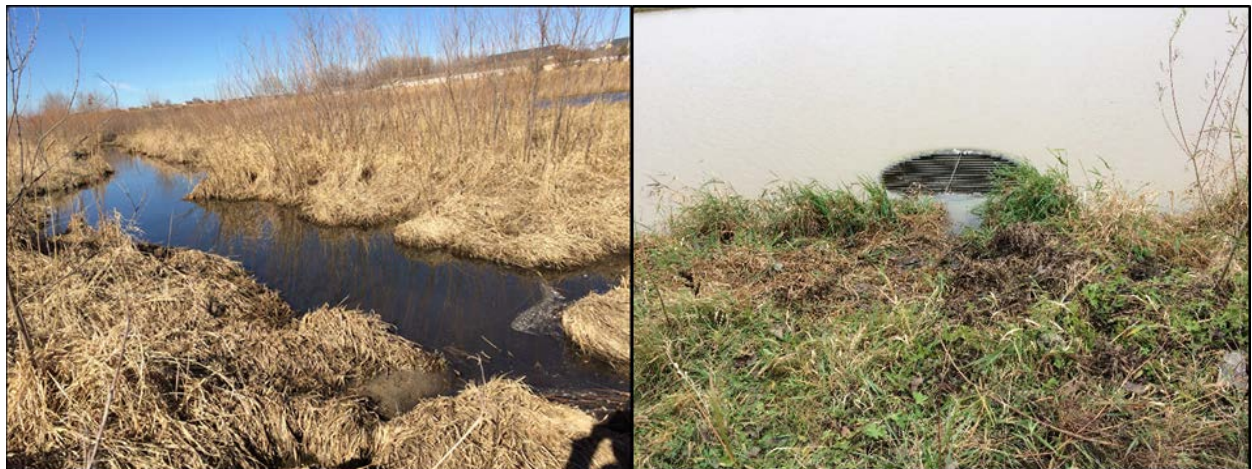
Figure 41. The image on the right is an example of a retention pond constructed in a new housing development in Cedar Falls. Retention ponds can be used to slow the rate of flow and artificially managing water, although the example on the right has a drain where the water would go down into the sewer system instead of flowing naturally into the stream or being infiltrated into the ground. The photograph on the left provides an example of a relatively successful restoration project; Located on UNI's campus, this wetland project is beginning to manage water effectively while providing positive influences on the Dry Run Creek and its overall health.

Retention ponds and constructed wetlands can be positive examples of remediation (Figure 41). With a growing number of urban development's proper retention pond educate really needs to be implemented to develop the most positive impact on the neighborhood as well as the streams health.

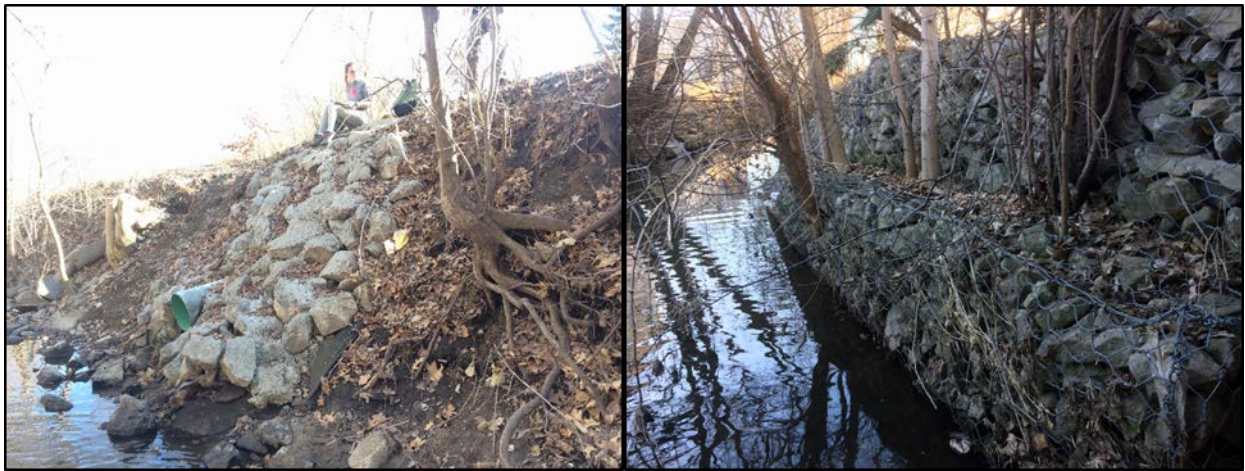
Artificial stabilization in urbanized areas commonly occurs along Dry Run Creek through Cedar Falls. Rip rap is used mostly throughout these sections. Some of these stabilization projects are effective; others make stabilization worse (Figure 42).

Figure 42. The image on the left shows a poor example of bank stabilization, where debris and cement was slopped into the stream and down the bank. Concrete is not a good way to stabilize it gives no movement for the stream and will speed up the waters movement causing more erosion to occur. The image on the left is between UNI's campus and College Street where apartments are being built, these apartments are right on the streams edge and rip rap was implemented to control bank erosion throughout this area. This kind of stabilization will help to prevent erosion, but not allow the steam to move at all.

Overall, the stabilization of banks along Dry Run Creek, should, demand our attention. With a growing urban population, it is imperative that stream monitoring, community outreach and education efforts continue for the future health of DRC and those that live, learn, work and play within its watershed. The Dry Run Creek Geomorphology Research Group plans to continue work this Summer and next Fall (2017). We are working to better characterize developments within the DRC watershed through field and laboratory (GIS, Geochemical, and particle-size analyses).
